PISCATAQUA RIVER BASIN
NOTTINGHAM , NEW HAMPSHIRE

DROWN'S DAM
NH 00136

PHASE I INSPECTION REPORT
NATIONAL DAM INSPECTION PROGRAM

JULY 1978

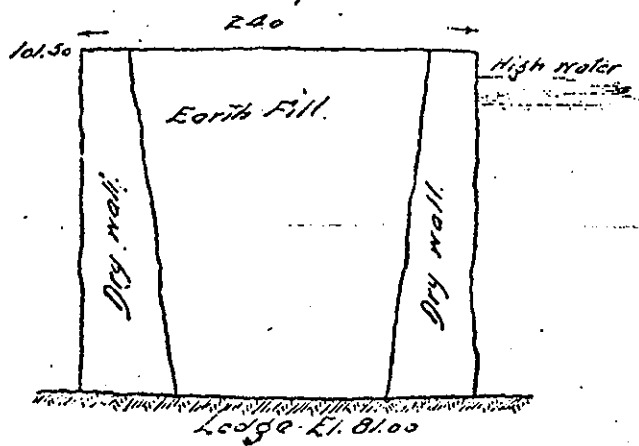
Cross Section
 of
 DROWN'S DAM (No. 2)
 Nottingham N.H.
 Scale 10' to the inch
 Copied Nov. 1918, by J.H. Litchfield.
 from drawings in a report by
 H.M. Oliver, C.E., to the Newmarket
 Manufacturing Co. dated 1889.

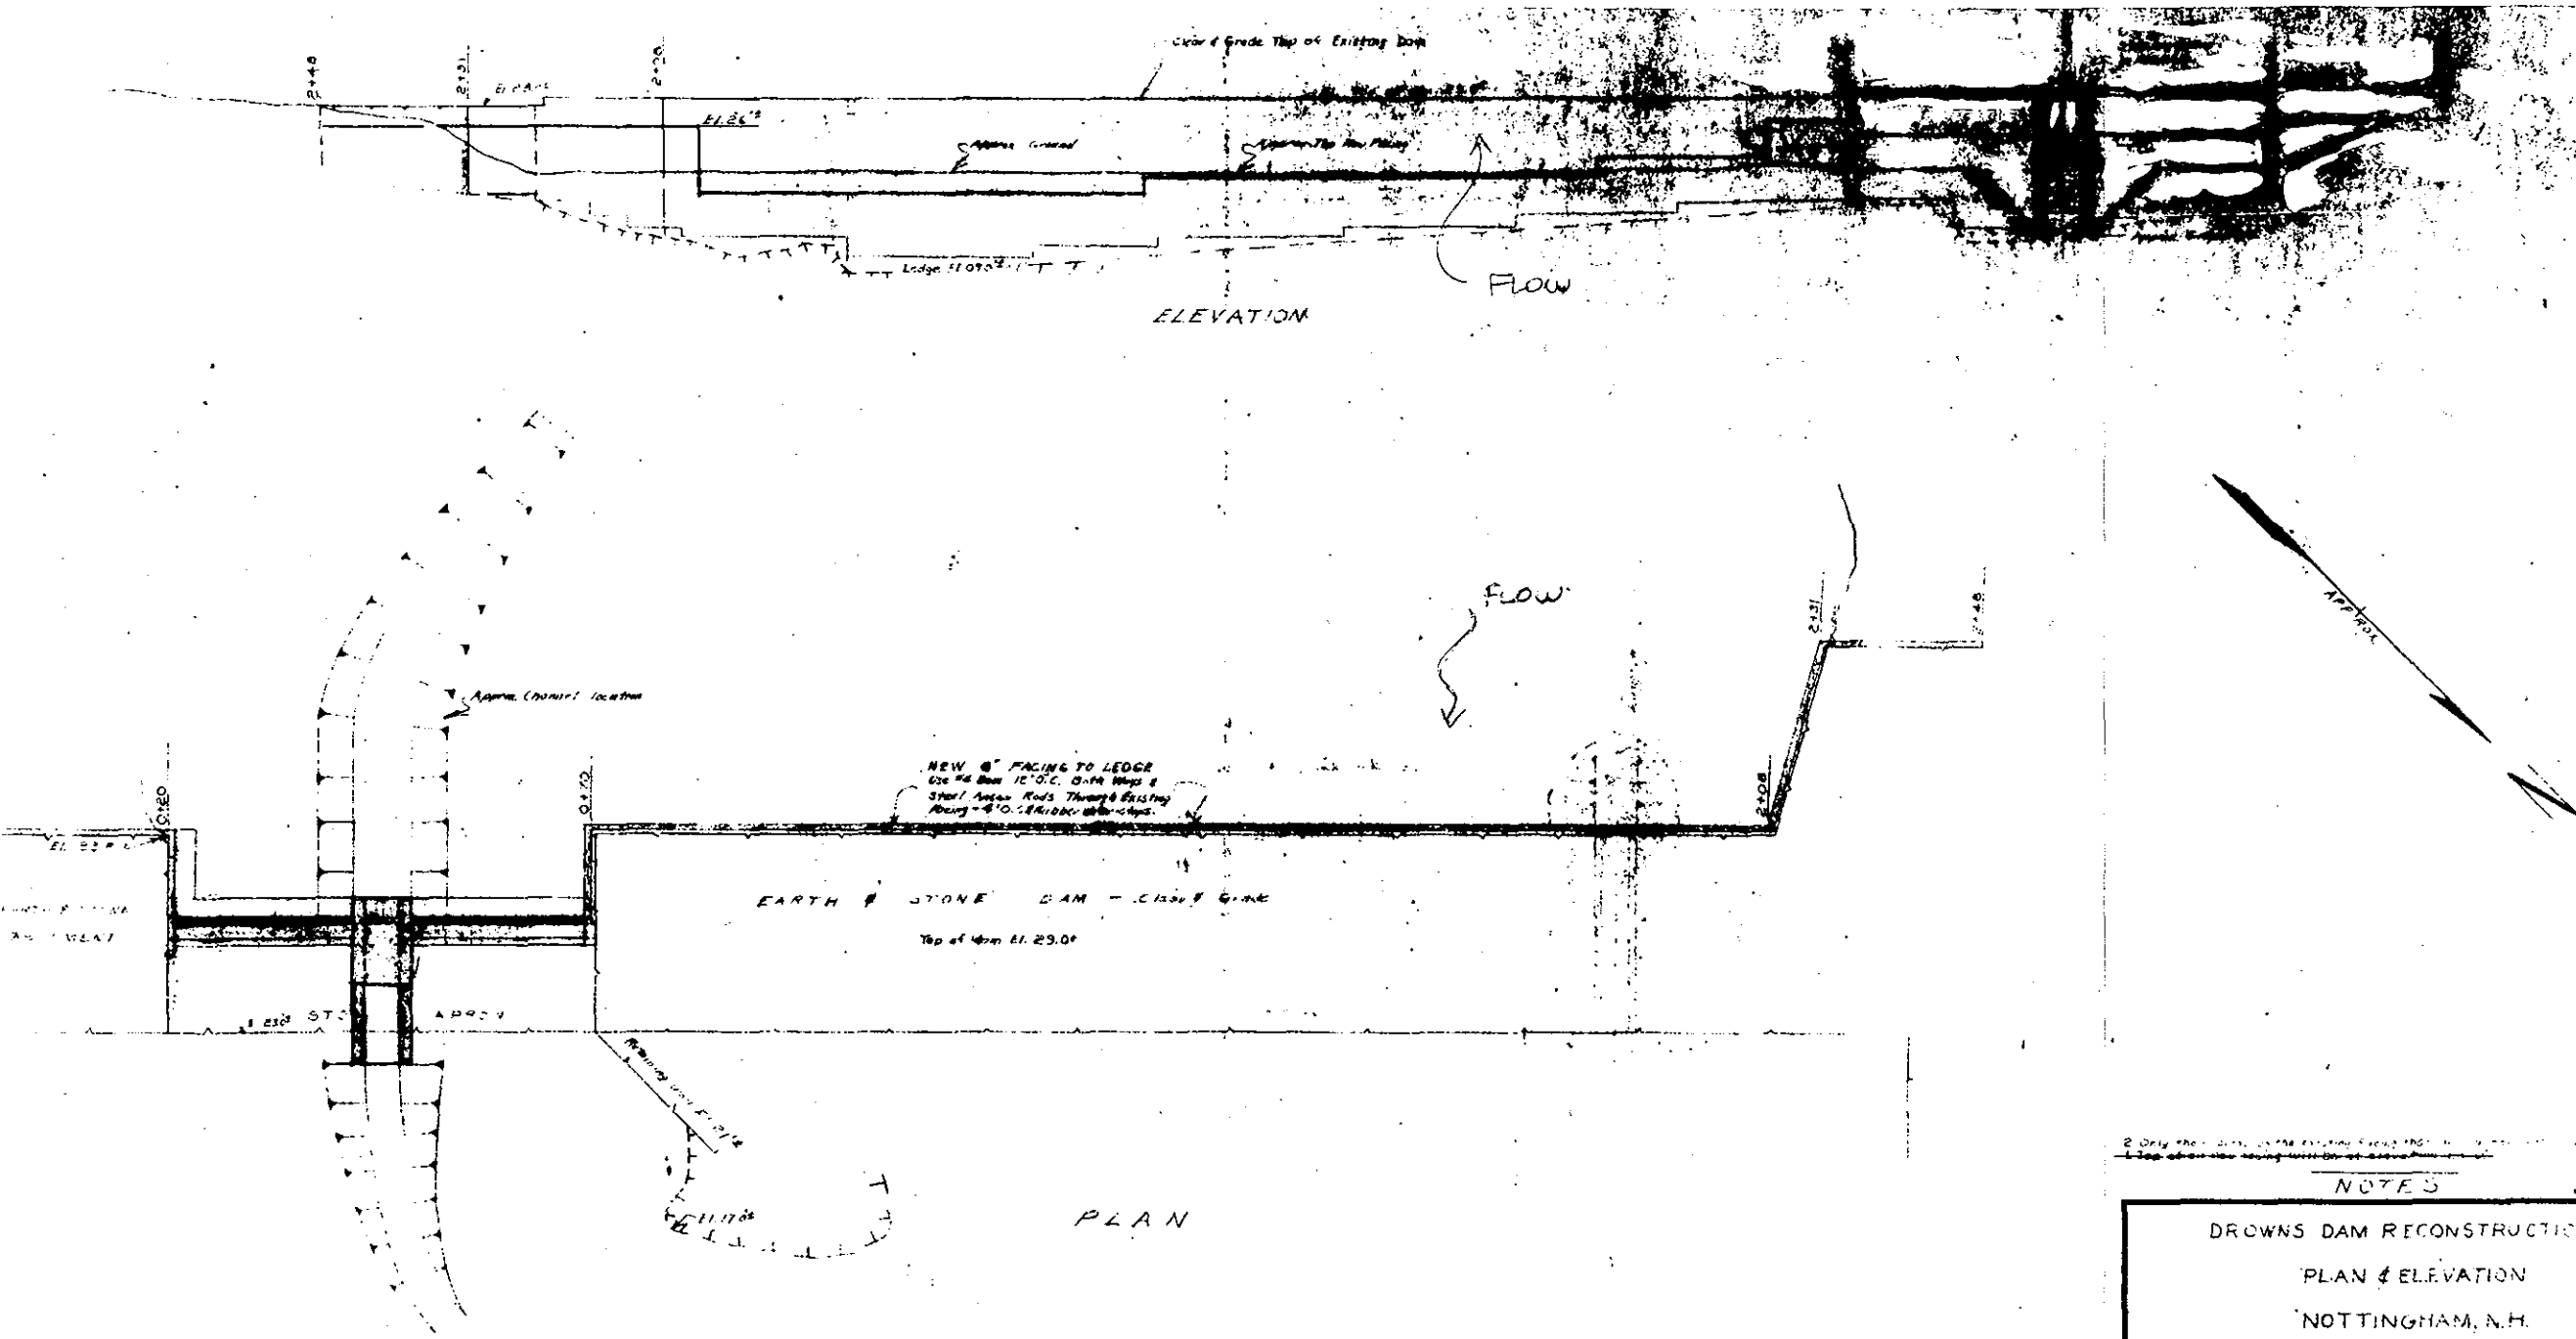
2. Only show work on the existing dam that is to be reconstructed.
 3. Top of dam to be reconstructed at elevation 11.5.

DROWNS DAM RECONSTRUCTION		
PLAN & ELEVATION		
NOTTINGHAM, N.H. 4/84.02		
NEW HAMPSHIRE WATER RESOURCES BOARD		
- CONCORD, N.H. -		
SCALE HORIZONTAL VERTICAL	SHEET 1 OF 1 SHEETS	DATE
